CLS Thales TH2161B system issues 2003-2024

Jon Stampe
Denis Beauregard

CLS system overview

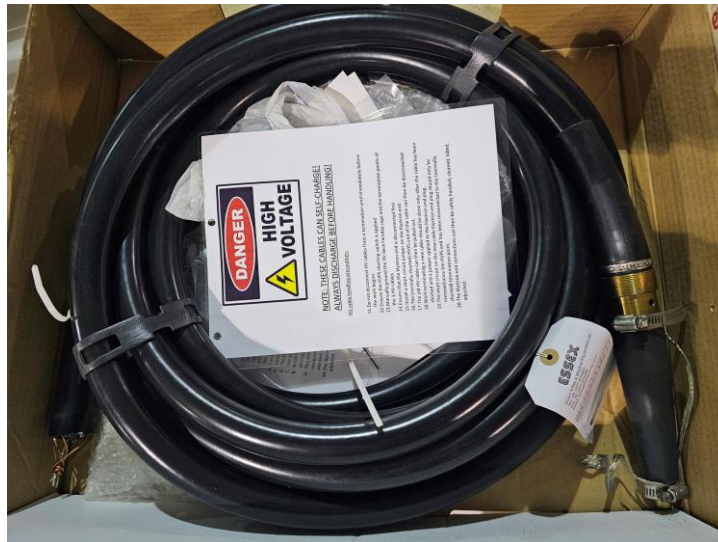
- Disconnected HV cables will self-charge to high potential and should be left shorted in storage and discharged whenever an open-circuit cable is to be worked on. Signage is recommended

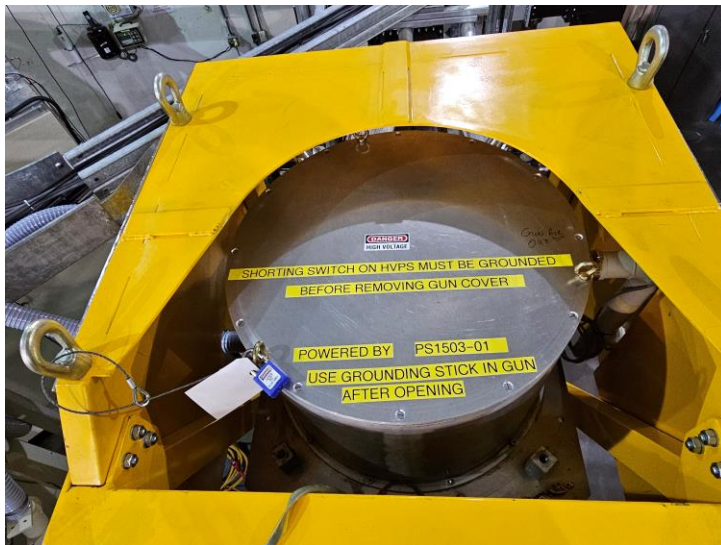
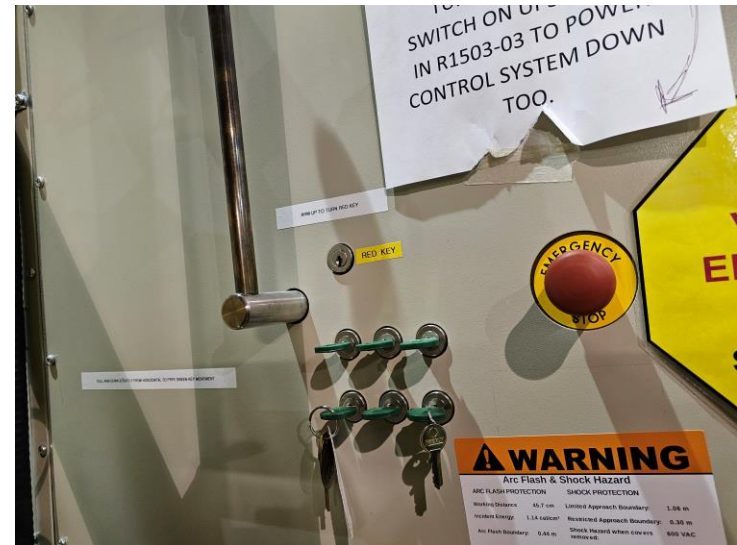
- No interlocking/prevention of klystron gun tank cover removal to HV cable and HVPS short-circuit mechanism activated status exists. Lock and cable to cover were added with the key attached to another safety key in the HVPS switch bank

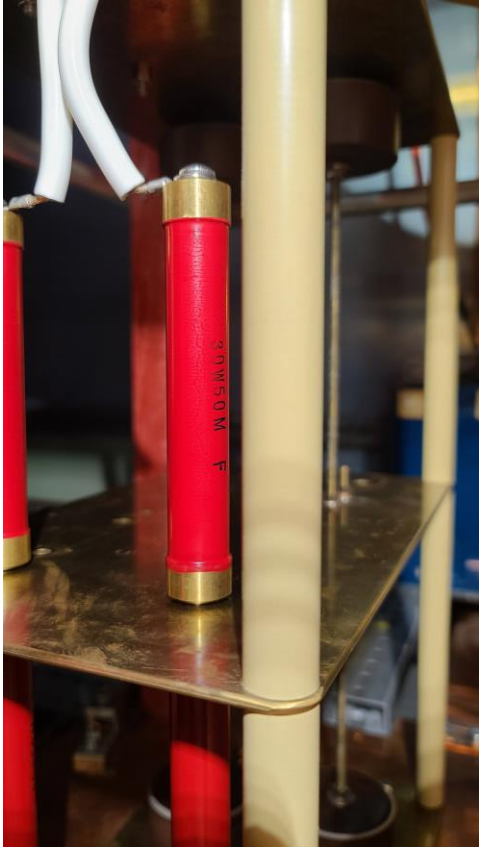
Cathode HV power supply High Voltage divider resistor and capacitor failures

- This was the temporary replacement
- Breakdown of HV coating on resistors in HV deck filter tank caused unequal voltage on series capacitors exceeding cap breakdown voltage

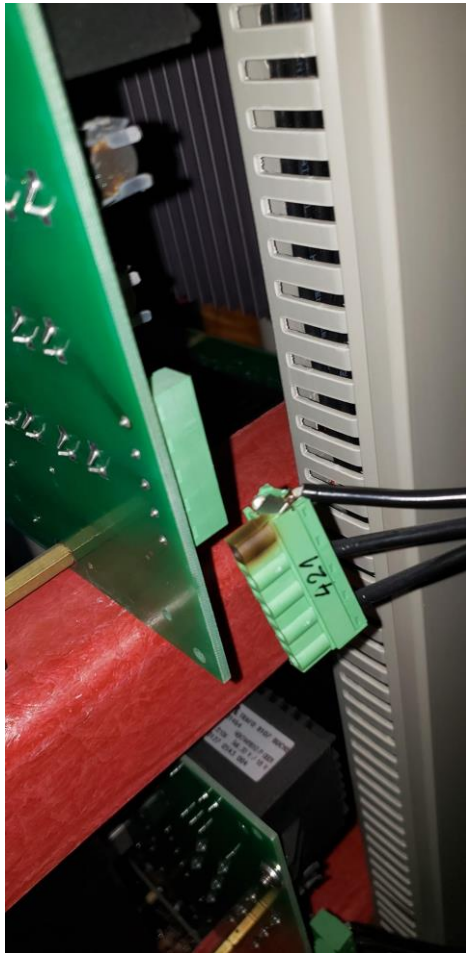
HV Switching module 3 phase AC mains input connectors burning up

- Was found before any symptoms were noticed.
- Replaced with higher current version

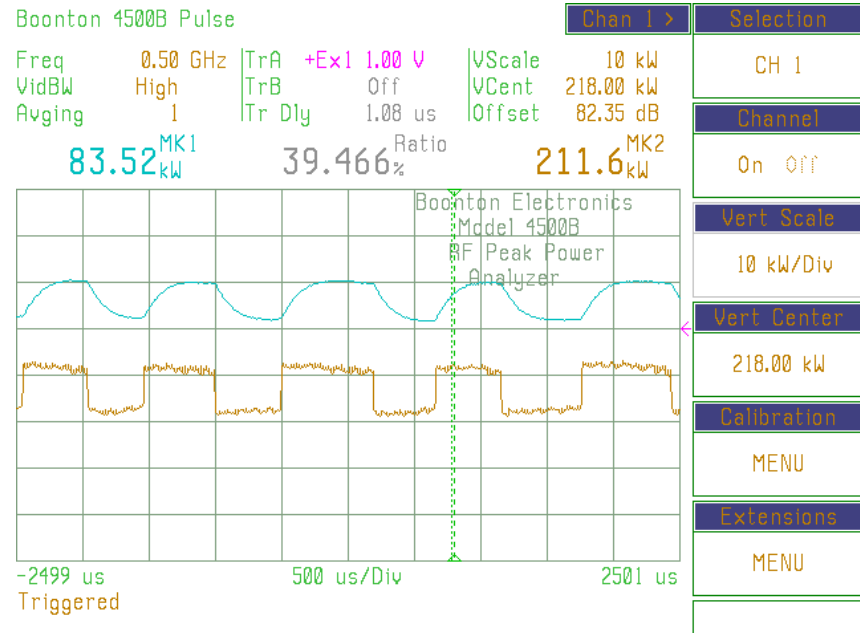
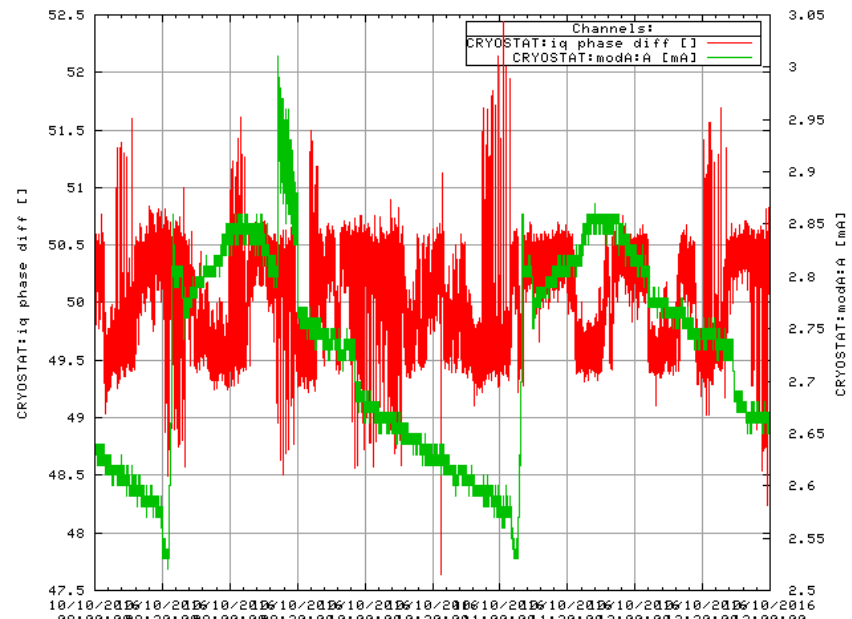
Klystron 161004
RF output power
and modulating
anode current
exhibit low
frequency
oscillation

RF output power
 and modulating
 anode current
 exhibit low
 frequency oscillation
 when operating in
 intermediate RF
 power range

- 47K hours on tube.
- Possible collector damage due to water system issues?
- Or effect of reflection magnitude and phase angle on effect observed.
- See paper references for 2 causes of similar effects. (last slide)
- Klystron kept as emergency spare for use outside affected RF output power range.
- Will try spotknocking tests on this tube initially

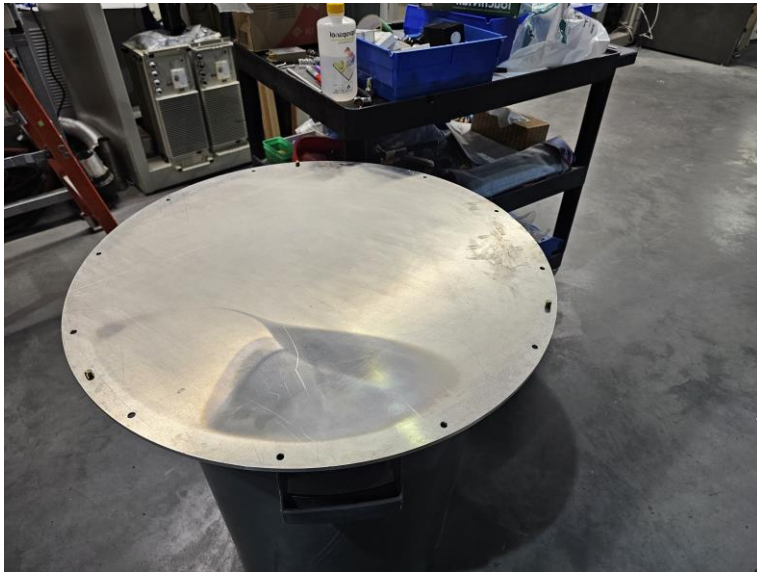
Ionization issues in klystron gun tank

- Routing of flexible Pantak to gun wires too close to cover (161003 and 161004)
- Internal mounting of sharp-edged klystron lifting blocks inside tank instead of outside

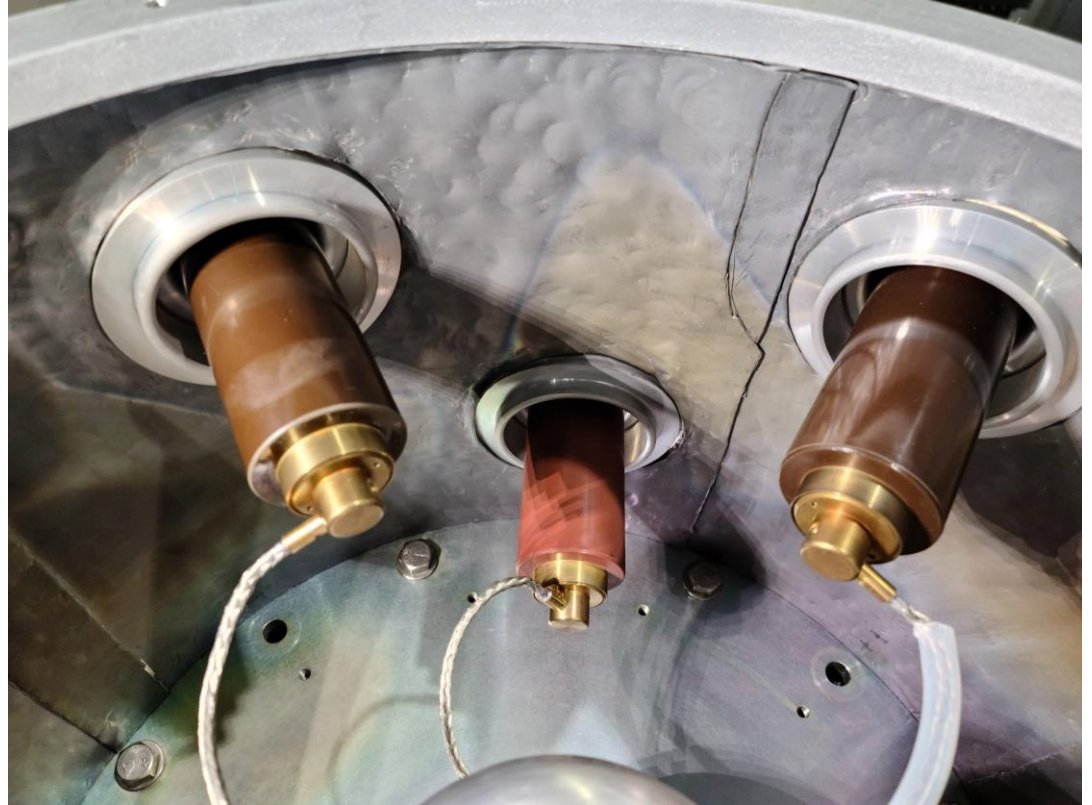
Ionization issues in klystron gun tank

Installation of
internal lead
shielding with
resultant lead
ion shower on
ceramics
(161033)

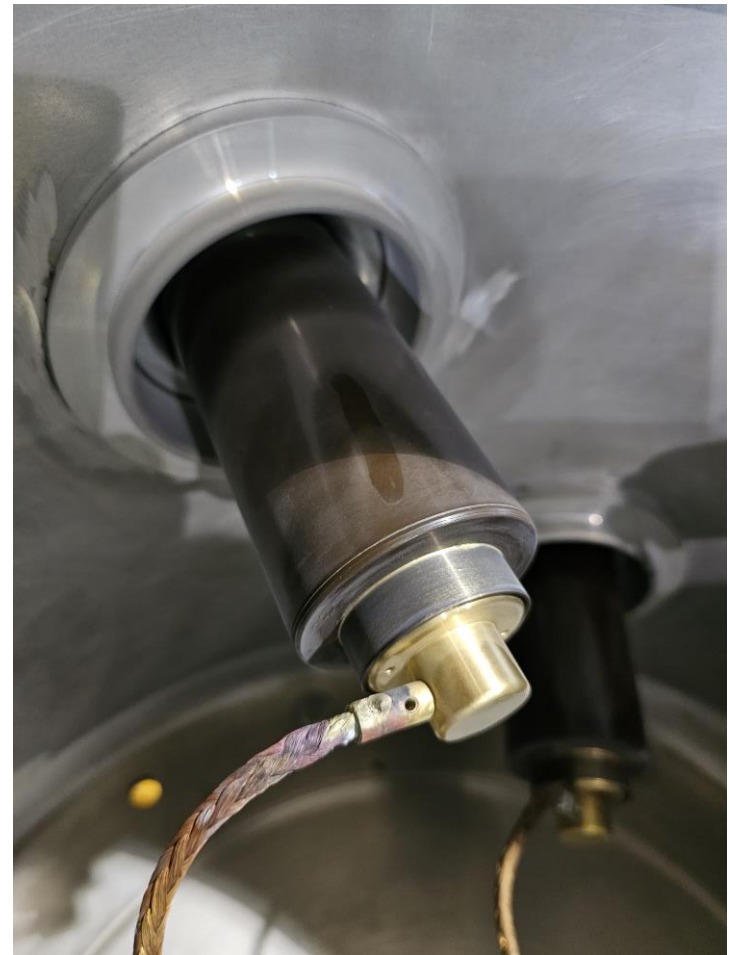
Klystron Gun and Window blower cabinet issues

- Shedding filter cloth material from locally sourced replacement internal blower cabinet filter caused mess in gun tank and RF window arcs.
- HEPA post-filtration to be installed as part of blower cabinet redesign

- Klystron Gun and Window blower cabinet issues: Always ran hot inside causing need for precooling of cabinet air input. This to prevent window air input overtemperature trips in hot weather. Window arcs- numerous causes from cabinet interior: crumbling hoses on blower air output from cabinet heat, deteriorating cabinet seals,. New cabinet with post filtration designed. Mechanical analysis of existing cabinet shows window blower selection was too large causing motor heating issue. This temperature aberration was also observed on early visit to NSLS2 during their amplifier commissioning.

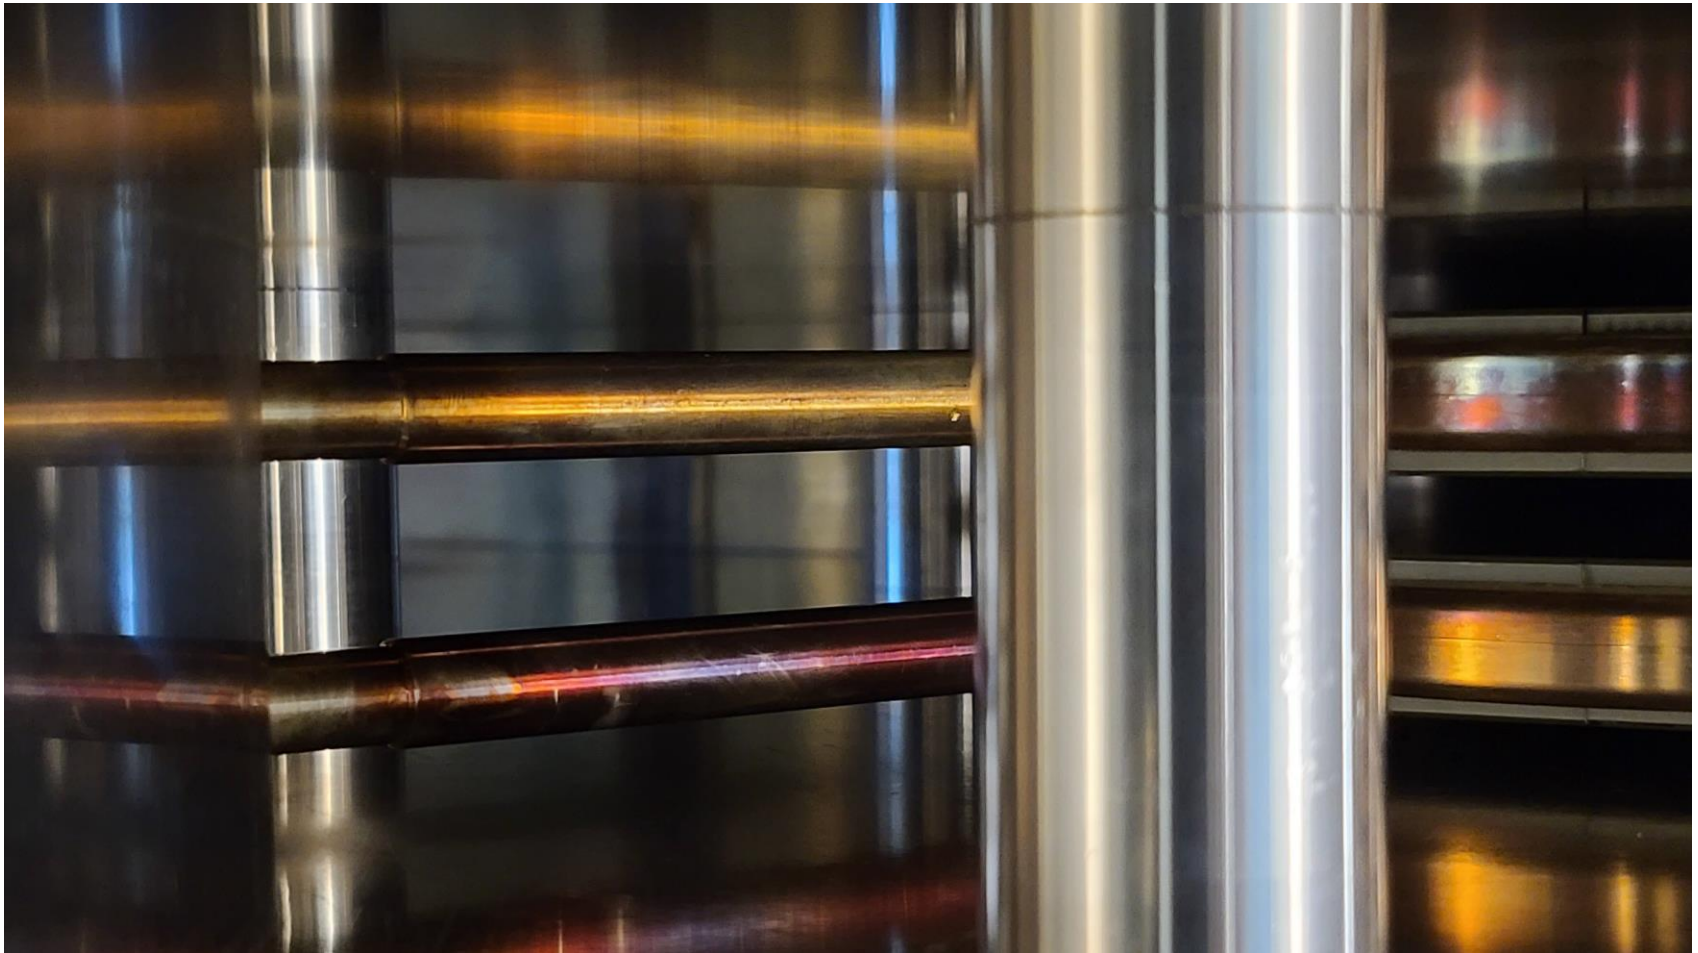
AFT circulator issues: high surface temperatures

- Temperatures (130 deg. C) on early unit at high H field standing wave phase.
- Port 1 cooling channel surfaces showing plating delamination and deep pitting of surface. Unit replaced to prevent potential klystron shower,
- Newer circulators have different cooling design and higher water flow specs. Ports still showing heating effects though.
- Amplifier power now limited to 250 kW CW.
- Poor “real world” measured power isolation of 19 dB at our cavity waveguide reflection phase on our initial unit.
- OK at low power. Better/good enough “real world” measured high power RF return loss seen on newer circulators, though some effects of later cavity iris Qext retuning may also be involved.
- Potential to extend cavity waveguide to move H max/E max standing wave longitudinal location relative to circulator ferrites, spacers machined but not fitted.

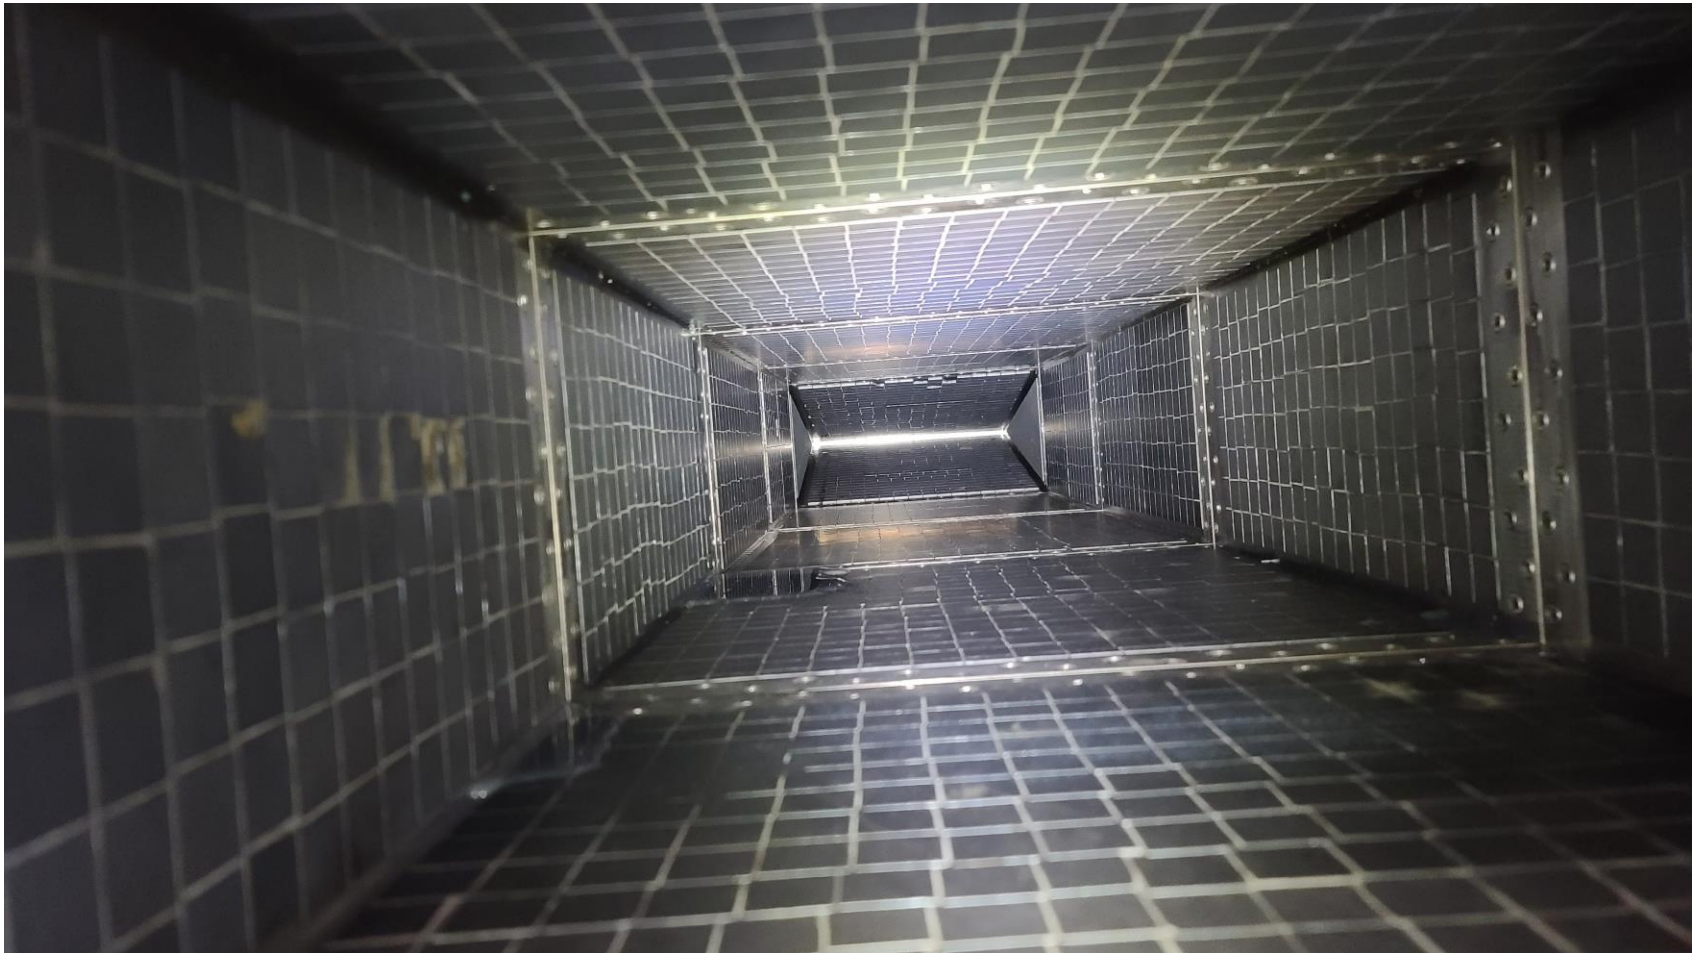
AFT RF load water leakage

- Test Load: circulator port 2 condensation noted after maintenance outage with system connected to load.
- Reject Load: sudden "flaring" of reflected power to klystron above 225 kW during circulator short circuit testing. Steam?
- Both loads found to be leaking at joints at e-plane/H-plane interior corners along length of load. Test load failure ~ 1 year before reject load.
- Spare load from BR RF installed to keep system running
